**Town Council  
WORK SESSION  
Tuesday, November 15, 2022  
Public Meeting Room / Eagle Town Hall  
200 Broadway Eagle, CO**

**SUBJECT:** Eagle Pool Analysis of Options

## Assessment of Conditions for Eagle Pool

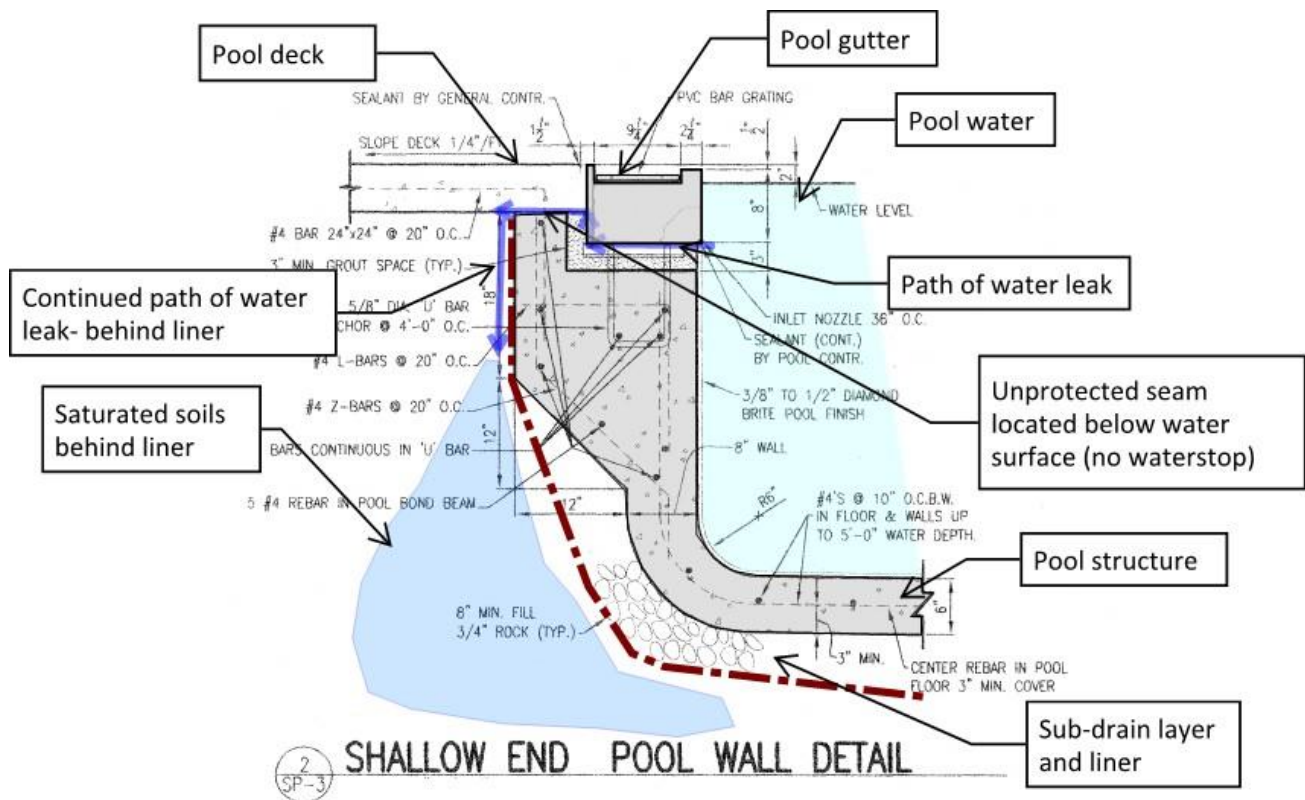
**Figure – Current Water Leak Conditions**

As shared from the WJE study, the observed water loss occurs from a seam/joint between the stainless-steel gutter and the concrete wall that is hidden below the concrete deck panels around the entire pool.

When reviewing the original construction drawings, it appears that the original designers of the facility were aware of the soils conditions and included a synthetic liner and underdrain system to contain potential leaked water from the pool structure. However, the system has not been effective in capturing the water leaking from the seam/joint under the concrete pool deck. Unfortunately, most water leaking from this seam/joint under the concrete deck panels was undetected and appears to be leaking behind/outside the liner and underdrain system becoming trapped in the subgrade as the constructed liner location and design is preventing it from being collected by the underdrain. See the figure below that represents the current condition with water leak and liner system.

As mentioned above, the main cause for the leak appears to be water traveling undetected under the stainless-steel gutter and through the unprotected concrete pool wall/concrete deck panel construction joint beneath the pool water surface as shown above. We believe this condition has been a common occurrence in the stainless-steel gutter concrete wall pool construction. Historically, gutter systems have been designed/constructed with a 6" or more step down from the pool deck down below the water level. In a case like this, the unprotected (no water stop) horizontal seam between the top of the concrete pool wall and the concrete pool deck is below the normal pool water line. With a previous trend toward deck-level gutters, it is placing this seam below water level and making it a potential source of leaking.

- **Remove and replace the stainless-steel gutter.** This would replace the existing gutter and require repairs that would allow it to be re-leveled. Given the bottom of the pool has differentially settled by 4 ½ inches, the grout bed beneath the pool gutter would vary by the same 4 ½ inches.

- **Repair the exposed water-proof liner** and extend it up along the back of the new stem wall.
- **Repair the stress crack** located in the floor of in the northwest corner of the pool resulting from the differential settlement.

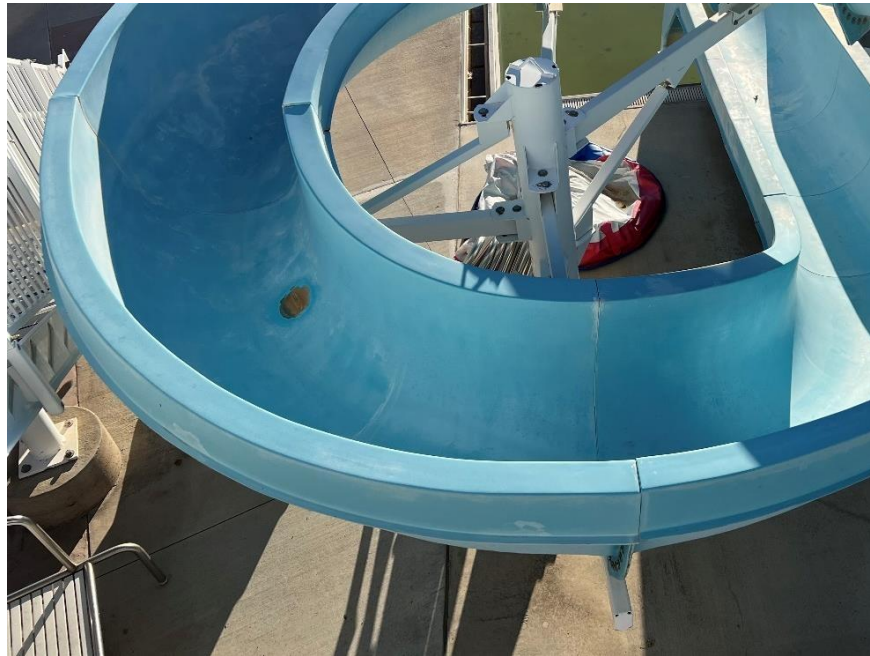
## **Waterslide**

At 20 years old, the water slide needs reconditioning, particularly the fiberglass ride gel coating. The coating has faded and worn thin, and the color coat has worn through in spots. Eventually fibers will become exposed and become a hazard to the riders. The fiberglass should be regel-coated on the interior surface and re-painted on the exterior.

Additionally, the pool structure has differentially settled relative to the catch pool structure. This has resulted in a gap of a couple of inches where the slide exit flume rests on the stainless-steel gutter. The gutter elevation will need to be adjusted up, or the closest support will need to be lowered.

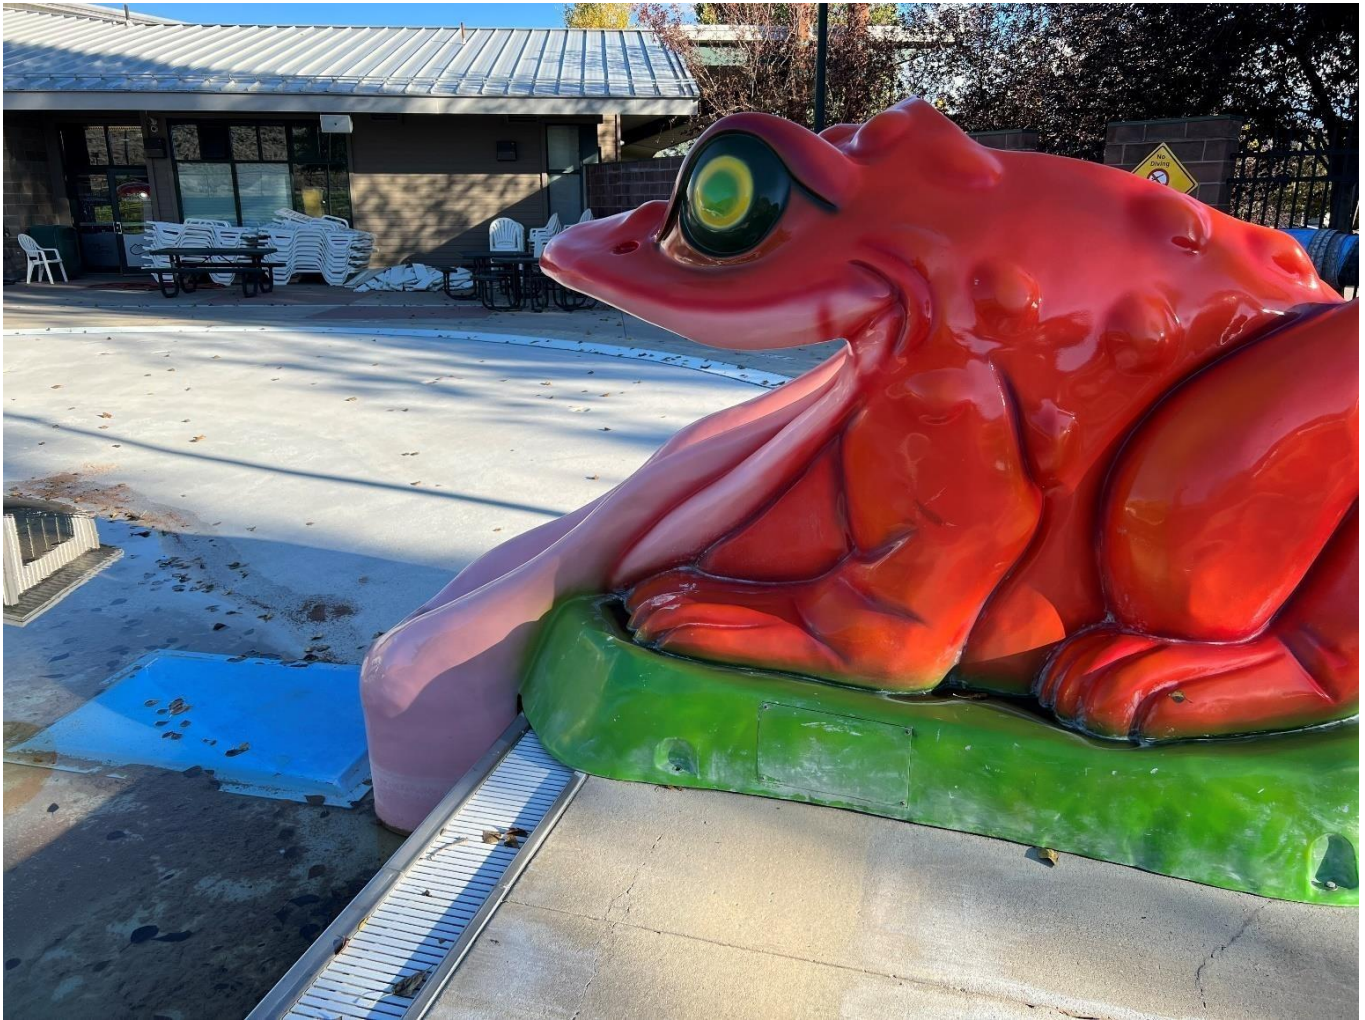
## **Toddler Slide and Spray Feature**

The toddler slide coatings have worn, showing its 20-year age. The coating on the surface could be refreshed. However, many communities find that it is not much more expensive to replace the feature than recoat. Additionally, a new feature will change things up a bit and would add some new life.

The same comments apply to the mushroom water feature concept. The coatings have work and it is ready for reconditioning. However, it may make more sense to install an alternate feature to add new life in lieu of

reconditioning.

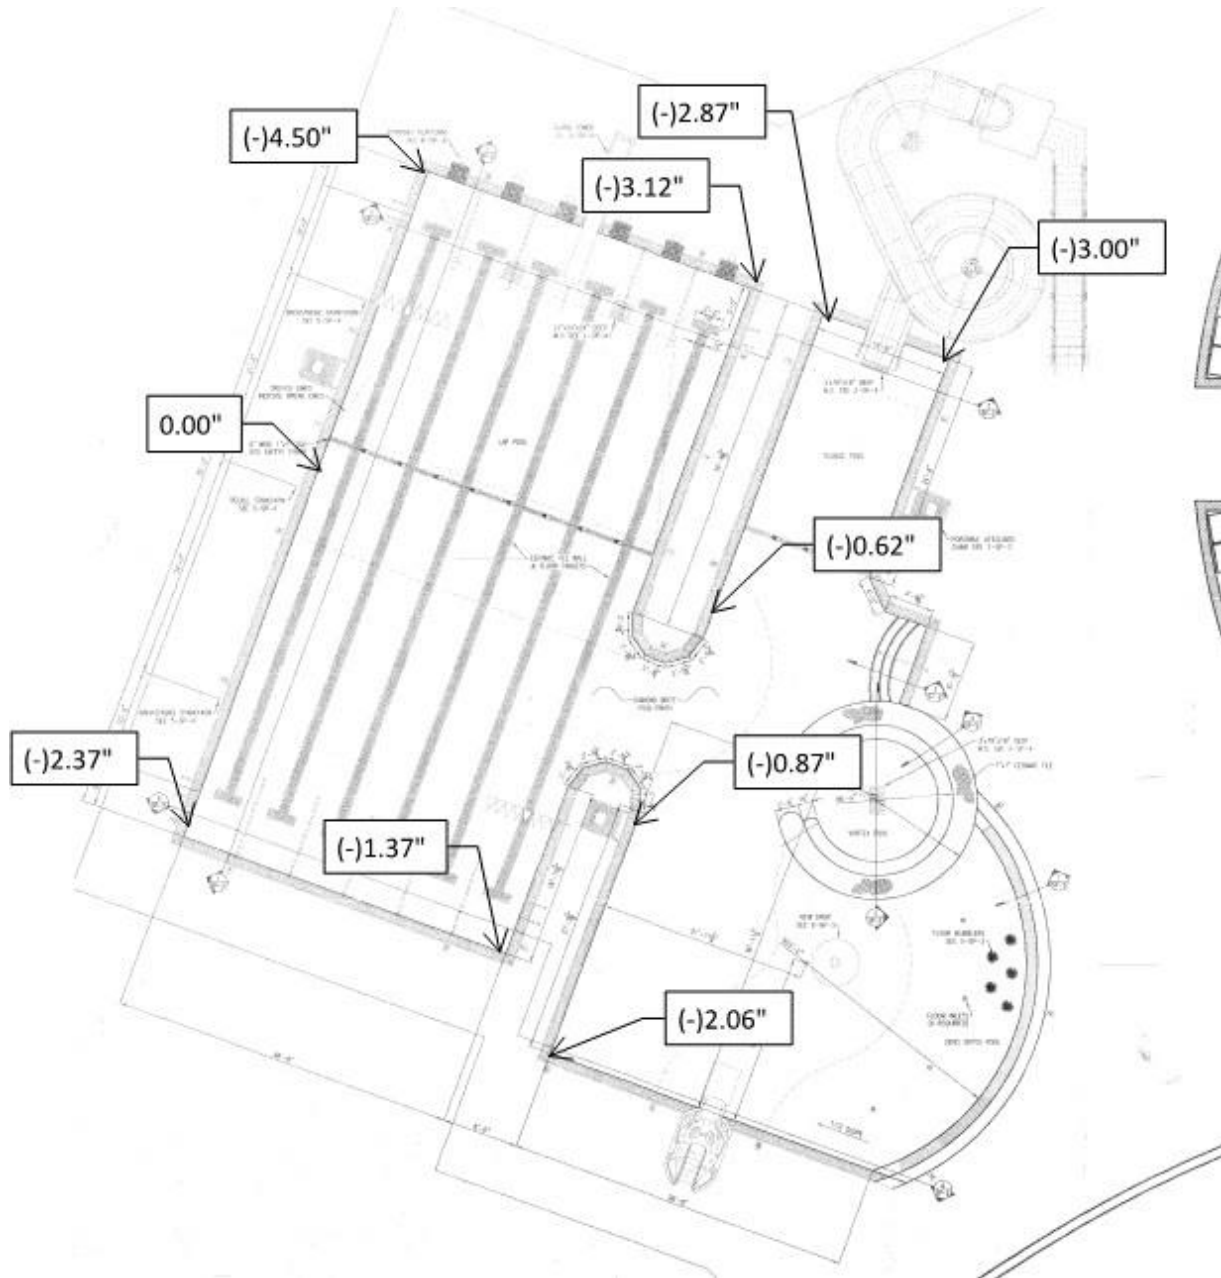
## APPENDIX A - Measurements of Settlement Surveyed by City Staff- 09/2022

Previous reports indicate that the pool has been affected since prior to 2014, and attempts have been made to address the conditions and repair leaks. Current conditions indicate that the pool continues to leak water and has an elevation difference as much as 4 ½ inches within the gutter lip across the pool. See Appendix A for measurements of pool settlement.
