**Town Council  
WORK SESSION  
Tuesday, November 15, 2022  
Public Meeting Room / Eagle Town Hall  
200 Broadway Eagle, CO**

**SUBJECT:** Eagle Pool Analysis of Options

## Assessment of Conditions for Eagle Pool

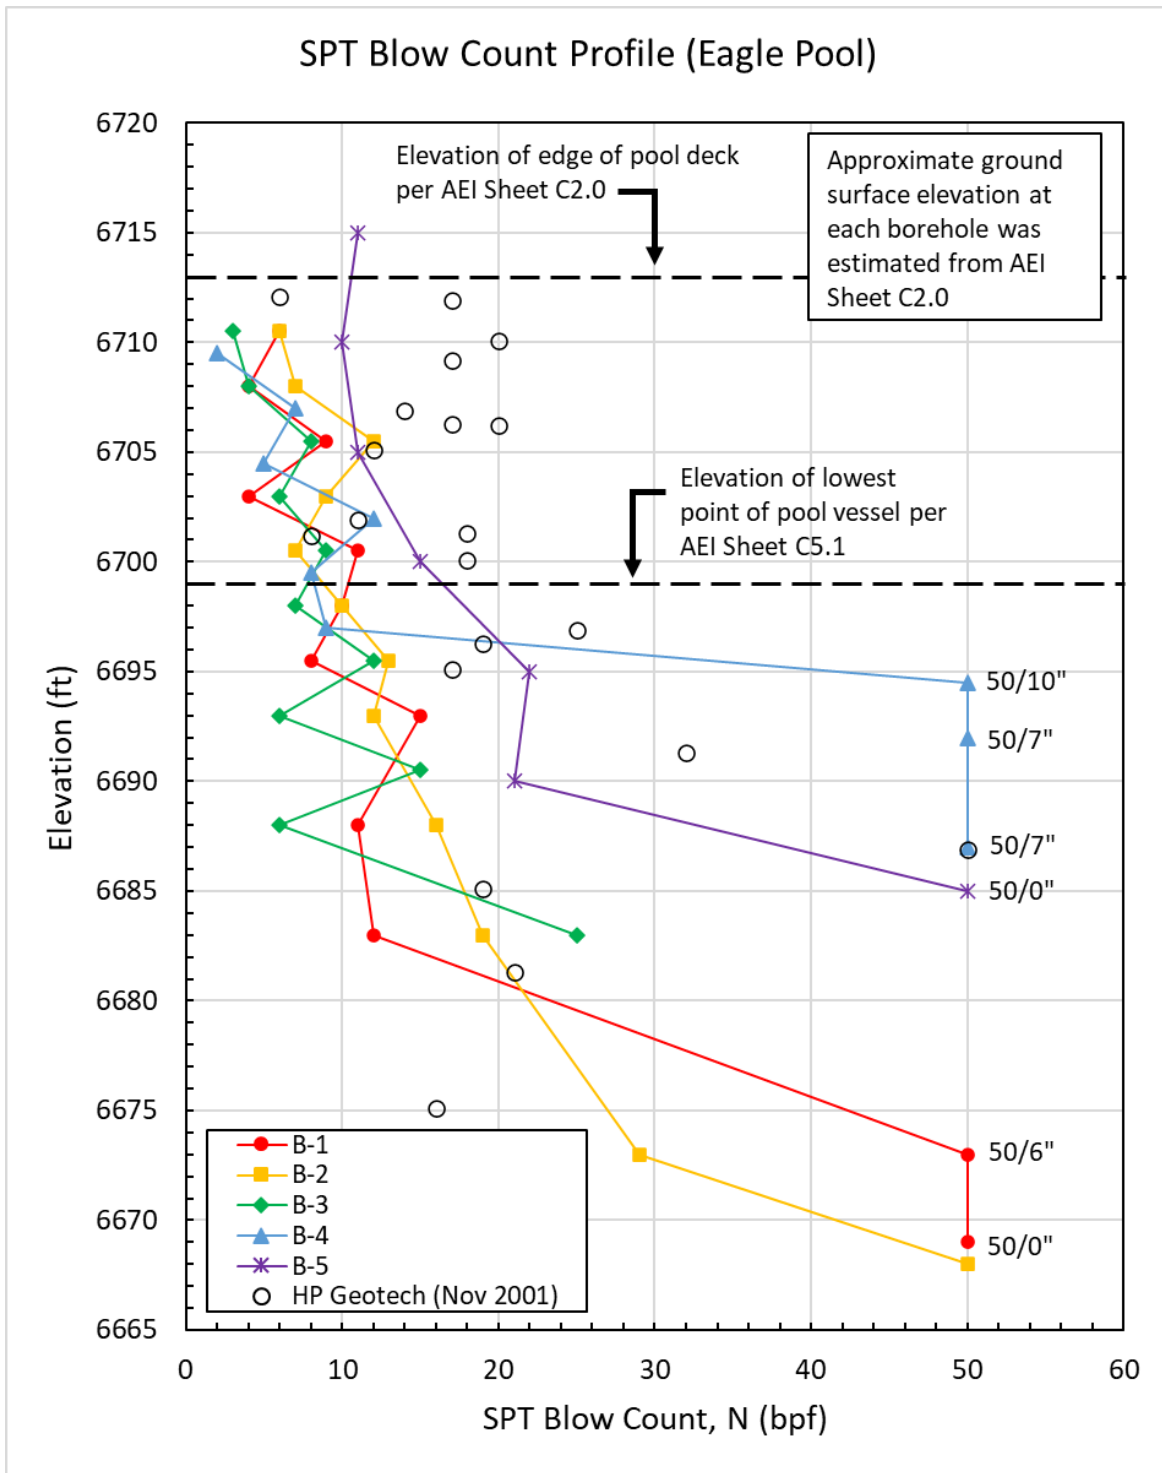
Figure 1. Subsurface Elevation Profile - Standard Penetration Test (SPT) Blow Count

2. As is apparent on Figure 1, SPT blow counts in our 2022 borings B-1 through B-4 are distinctly lower than our B-5, which was drilled outside of the pool area to the north, as well as the 2001 HP borings. This pronounced decrease in the SPT blow counts is consistent with collapsible soil behavior. These soils lose strength and volume when their moisture contents increase. The lower blow counts represent a significant loss of strength. This comparison of “before and after” blow counts indicates, in our opinion, that to some degree, the soil profile around and under the pool, as represented by borings B-1 through B-4, has indeed been subject to increased moisture content and collapse behavior.

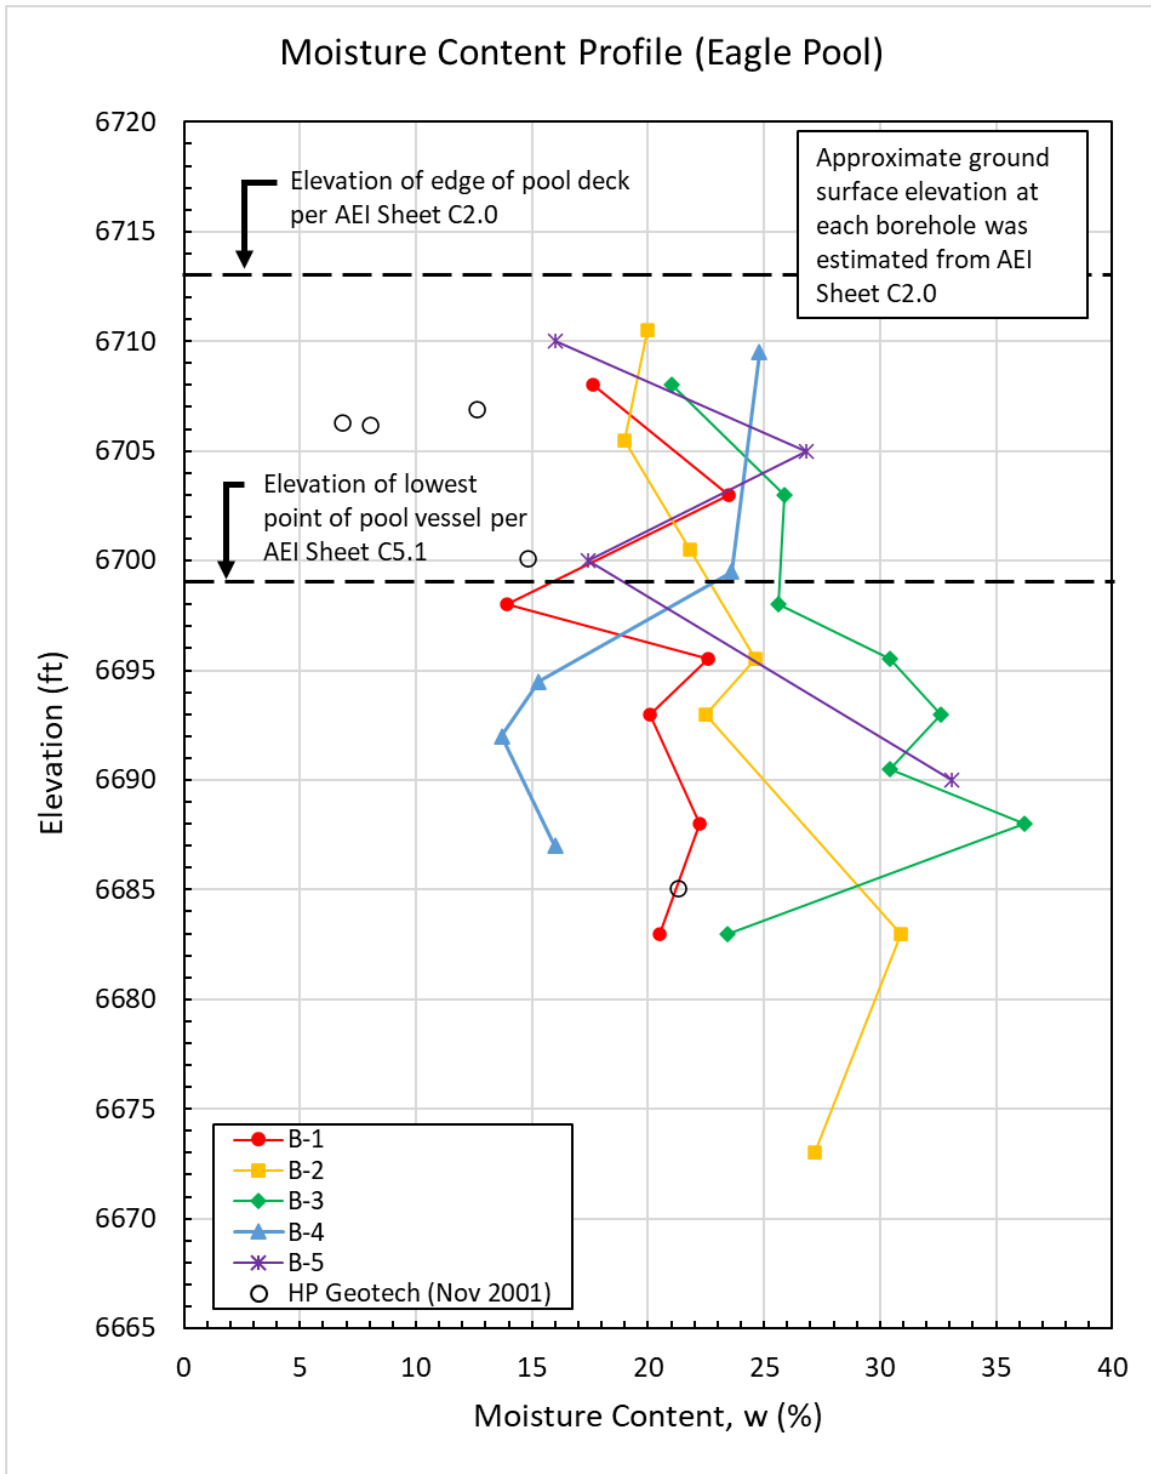
Figure 2. Subsurface Elevation Profile – Moisture Content

3. Figure 2, which depicts moisture content vs. elevation, also confirms that moisture contents have increased profoundly in and under the pool area in the roughly 21 years since HP’s borings were drilled. Like Figure 1, this plot also confirms that the soil profile around and under the pool has been subject to moisture infiltration and collapsible soil behavior.

4. Figure 2 specifically indicates that boring B-3 exhibited significantly higher moisture contents, particularly at elevations below 6700 feet (the approximate bottom of the pool), than borings B1, B-2, and B-4. Note that B-3 was drilled at the corner of the pool that has settled the most, where the greatest pool leakage was observed (at TP-2), as discussed above.

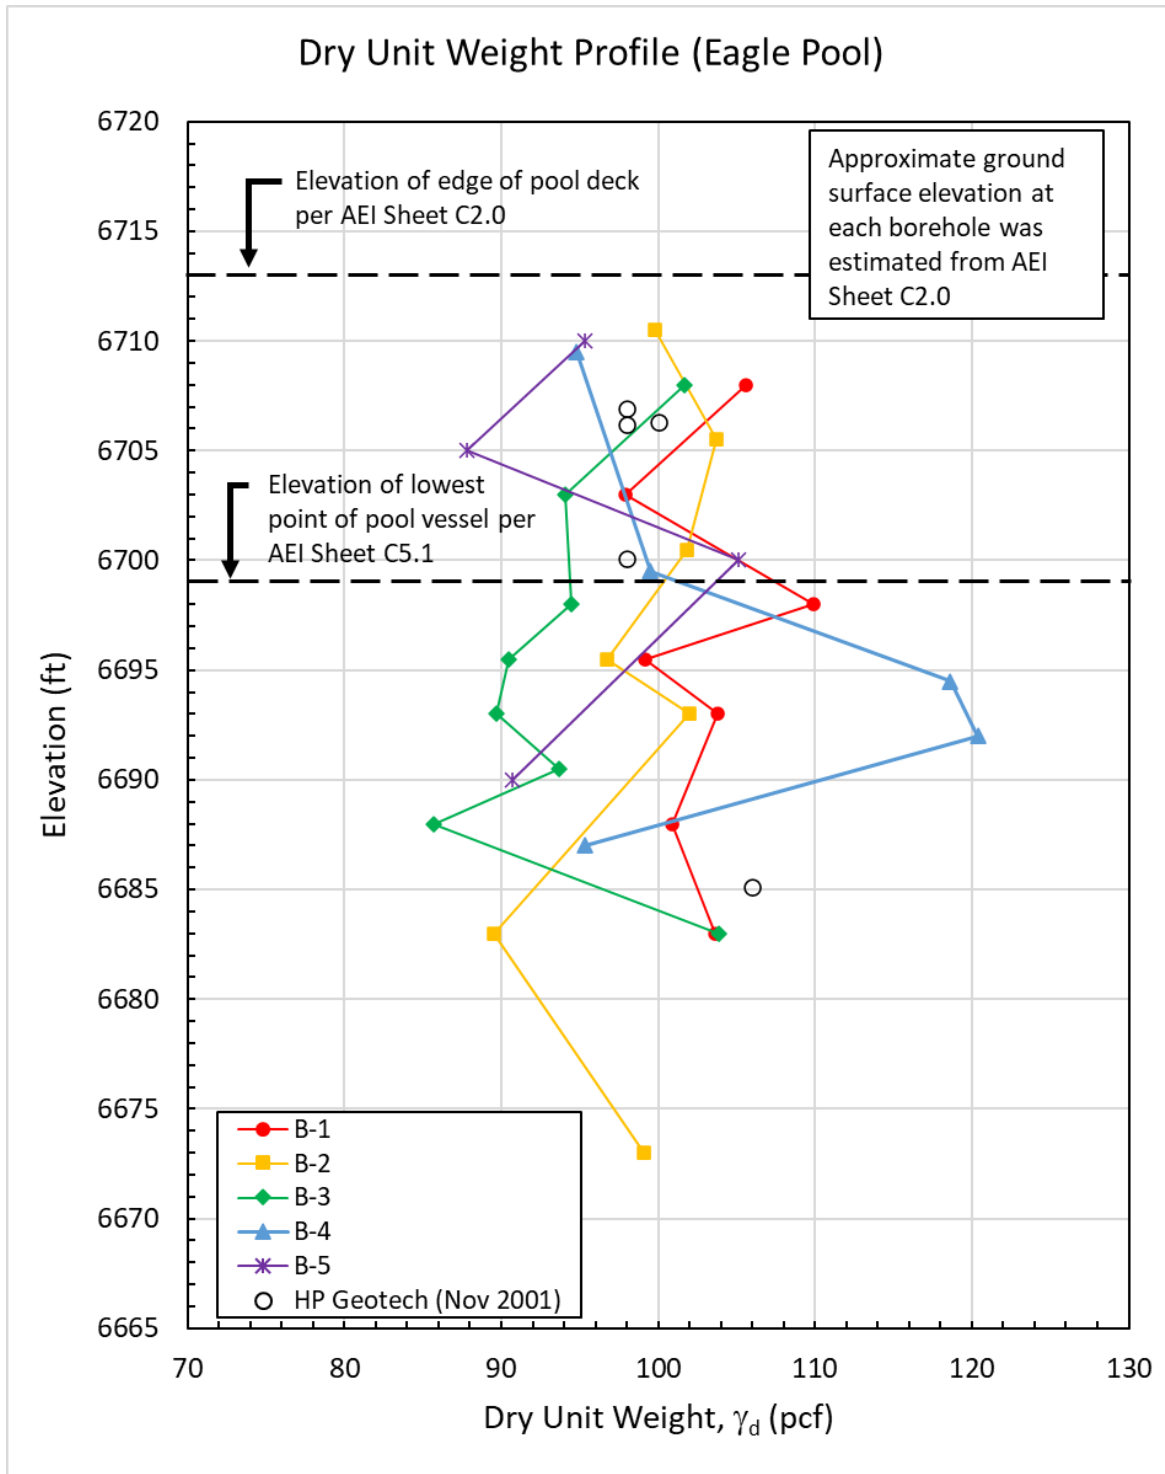
Figure 3. Subsurface Elevation Profile – Dry Unit Weight (Dry Density)

7. The plot of dry density vs. elevation (Figure 3) is less informing. The plot does not appreciably indicate a change in density from 2001 to 2022. One would expect dry density to increase as soil collapse occurs, but the plot does not particularly indicate this. We attribute this largely to sample disturbance. It is difficult to get truly undisturbed samples in collapsible soils (because they are collapsible), and so this particular plot is less informative. By contrast, the SPT blow count and moisture content plots are not affected by sample disturbance, and in this case are more informative.

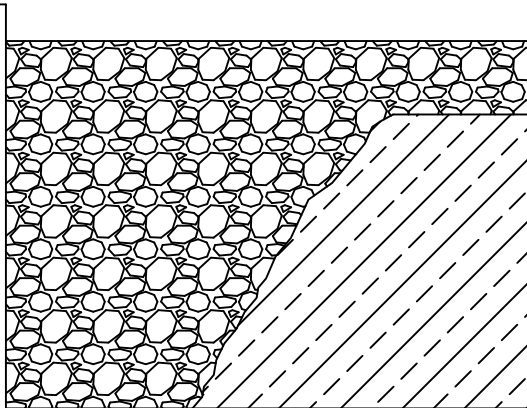
Bottom of test pit at 5.5 feet below the top of the concrete pool deck.

Extended pit around NW corner of pool after observed water running down pool wall and a cavity/void under pool deck near NW corner

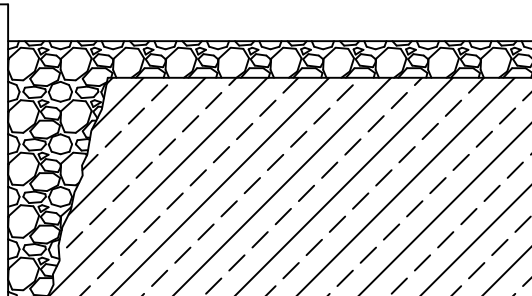
Bottom of test pit at 4 feet below the top of the concrete pool deck.

Multiple water leaks at joint between gutter and concrete pool wall
